TMS320TCI6612

Communications Infrastructure KeyStone SOC

Silicon Revisions 1.0, 1.1, 1.3

Silicon Errata

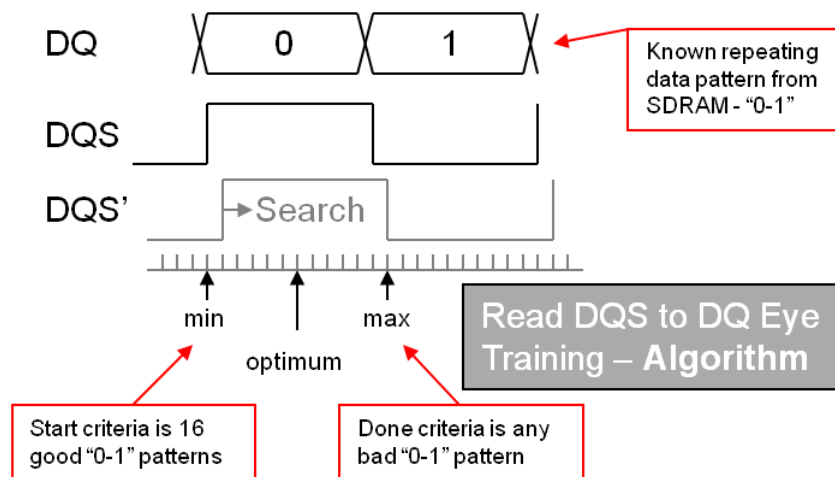
Figure 7. Read DQS to DQ Eye Training - Algorithm

As shown in [Figure 7](#), the Read Data Eye Training algorithm should correctly detect the extents of the DQ data eye. The SDRAM are put into a DQS to DQ eye training mode and read back an alternating 0, 1 pattern.

The DDR3 PHY uses this pattern to detect good or bad data being sampled by the DQS transitions. The DDR3 PHY searches by delaying DQS relative to DQ until these constraints are found.

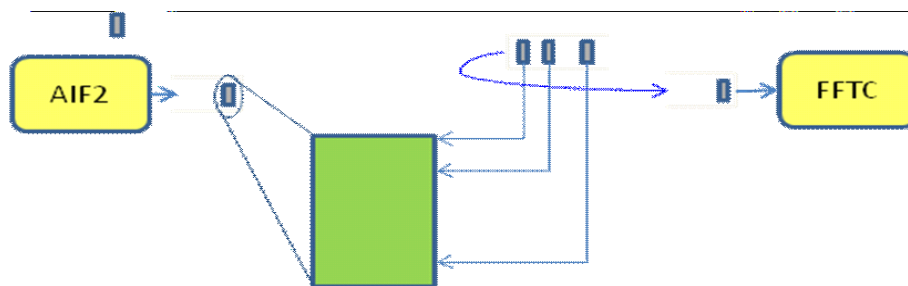
Figure 12. Symbol Processing on Ingress

- On ingress, the symbol processing is not triggered upon receiving the jumbo packet, instead it is triggered based on AT event. As AT event doesn't have association with the availability in memory, application needs to program AT event with enough offset to the actual symbol timing to guarantee the data availability in memory.
- On egress, no need to produce the entire jumbo packet before pushing the packet to AIF2, symbols can be produced on symbol basis with enough margin before AIF2 needs it. The margin is related to the pre-fetch buffer size set in AIF2.

Pre-configure a set of descriptors that point to the correct offset in jumbo packet for each symbol, store the descriptors in the FFTC Tx FDQ or an array. AT event trigger the EDMA to pop and push the descriptors from FFTC Tx FDQ to FFTC Tx Q. EDMA needs to pop the descriptor from the Tx FDQ and push to the FFTC Tx Q. If the AIF2 output packet PS words are needed, then it will need to be copied by EDMA before pushing the descriptor to the FFTC Tx Q. If using AT event to trigger EDMA, after pushing the descriptor, EDMA needs to clear the CP_INTC to prepare the subsequent AT event trigger. As there is no real need for the AIF2 output queue itself, AIF2 Rx Q can be set to be the same queue as the Rx FD, Therefore no need to recycle the AIF2 output
