Errata

J784S4, TDA4AP, TDA4VP, TDA4AH, TDA4VH, AM69A Processors Silicon Revision 1.0

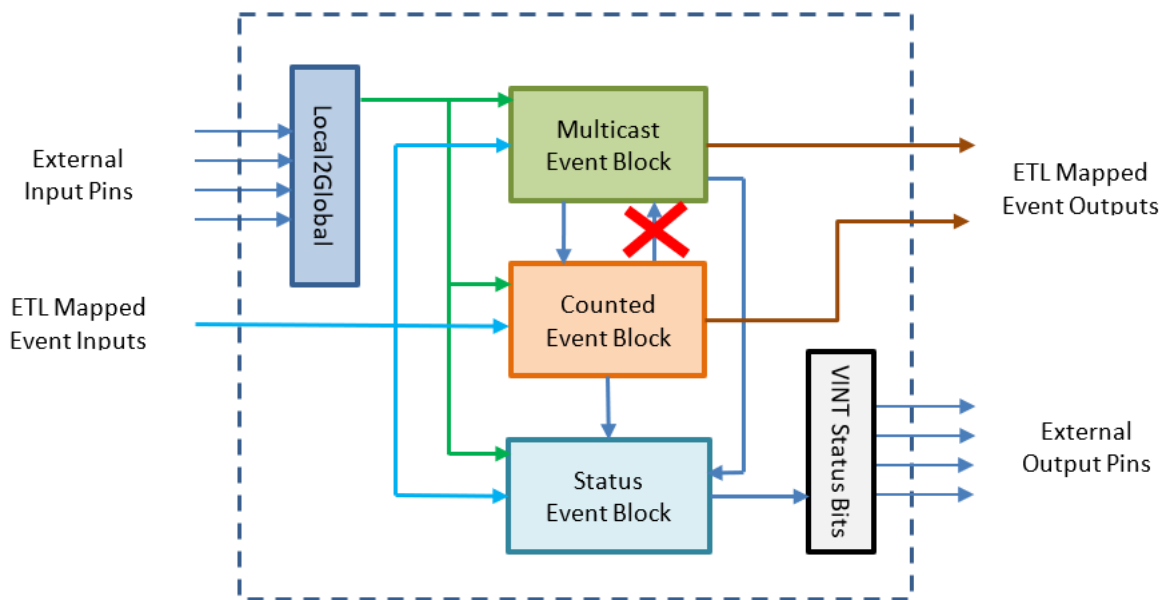
Figure 3-3. Interrupt Aggregator Version 1.0

Figure 3-3 shows the conceptual block diagram of IA 1.0. Potential loops are avoided by adopting the policy of not allowing the counted event block to send events to the multicast block. This method was chosen because it is more common to split an event first, and then count one while sending the other elsewhere. With this path blocked by convention, it is not possible for a single event to visit any block more than once and thus not possible for paths to become blocked so long as the outputs remain unblocked.

By following the conventions outlined here, the system is safe from looping hazards that can create a deadlock scenario.
