# **TMS320C6474**

## **Digital Signal Processor**

### **Silicon Revisions 2.1, 1.3, 1.2**

## **Silicon Errata**

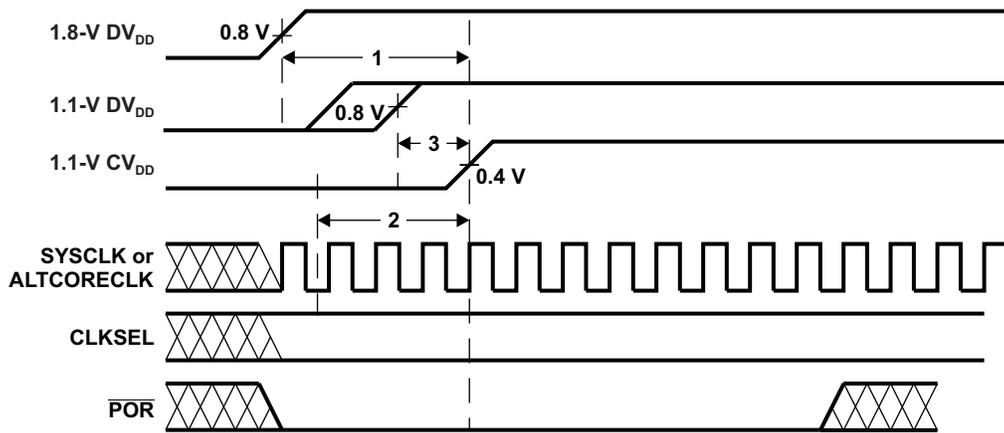
Figure 10. Correct Device Input Clocks, Clock Selects, and Scaled Supply Timings

Guarantee that the 1.8-V  $DV_{DD}$  device input clocks and clock selects are active before a 1.1-V  $CV_{DD}$  scaled supply ramps (see [Table 18](#) and [Figure 10](#)).

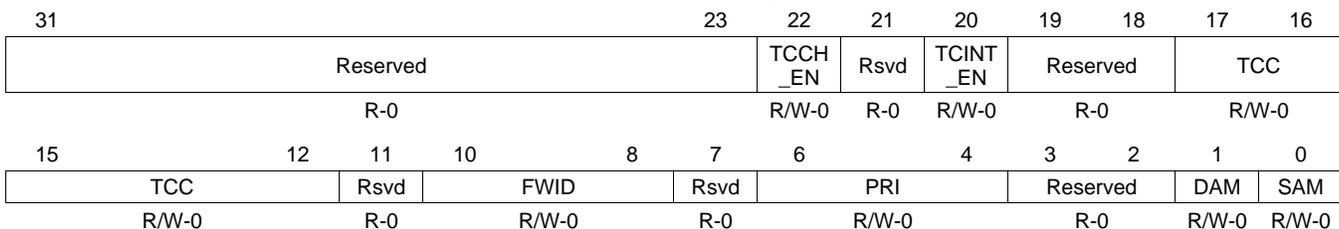
**Figure 11. Prog Set Options Register**

The Prog Set Option register is shown in [Figure 11](#). The TCINTEN bit should be set to 0x1. The TCC code should be set to some known value that is not used by other requests in the system. The other fields should be set to 0x0. Upon completion of the transfer, the TCC value will be set in the corresponding bit in the IPR/IPRH registers. The software should poll for this bit in the IPR/IPRH registers and then clear it with the ICR/ICRH registers before programming the next COMPACTV decrement transfer.
