OMAP5910
Dual-Core Processor
Silicon Errata

SPRZ016F
August 2002 – Revised February 2006

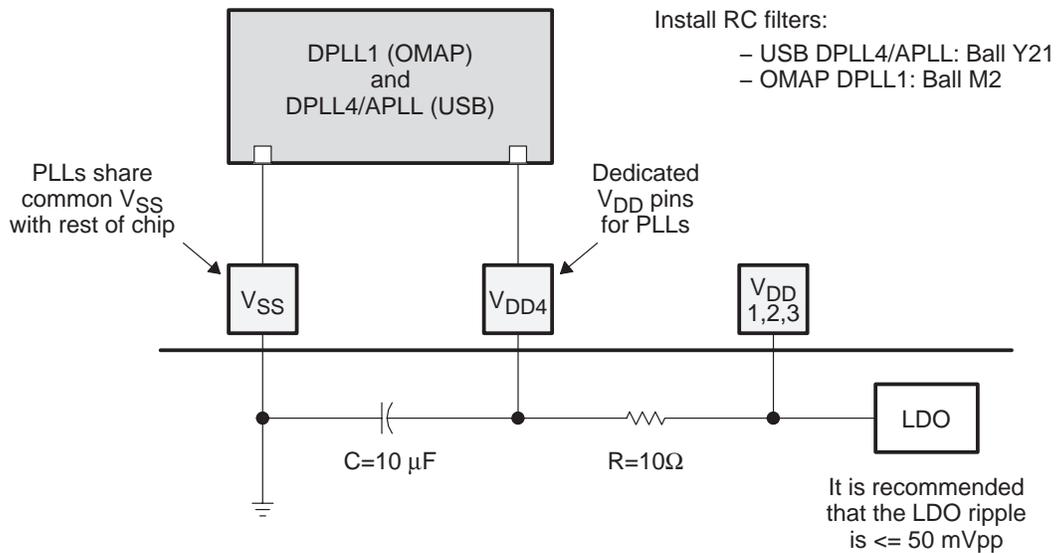
Figure 2. PLL Diagram

To reduce jitter, minimize power supply noise on V_{DD4} and V_{DDA} by the use of filters or bypass capacitors. A potential solution is to use the following circuit:

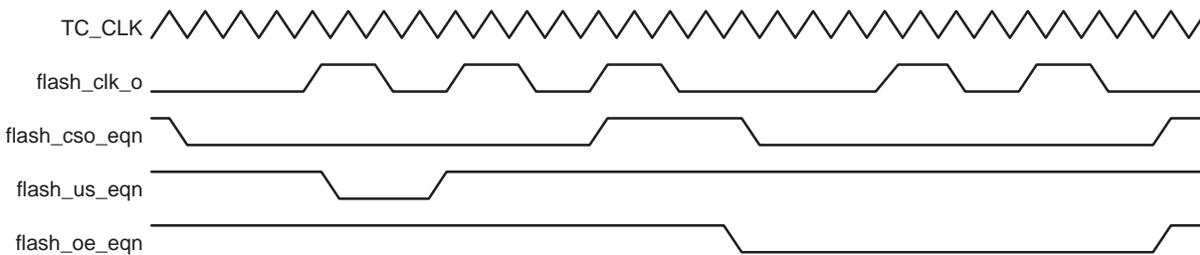
Figure 4. EMIFS Write and Read With Correct Flash Clock SDRAM

Figure 3 shows the problem in detail. It can be observed from the waveform that the first read immediately after the write operation has an extra clock pulse of width 1 TC clock cycle using FDVI = 4. For FDIV = 6, the pulse width is 2 TC clock cycles.

Figure 4 shows the flash clock with the correct configuration.

Workaround: In order to avoid data corruption, software needs to insert a dummy read/write to a asynchronous chip select.

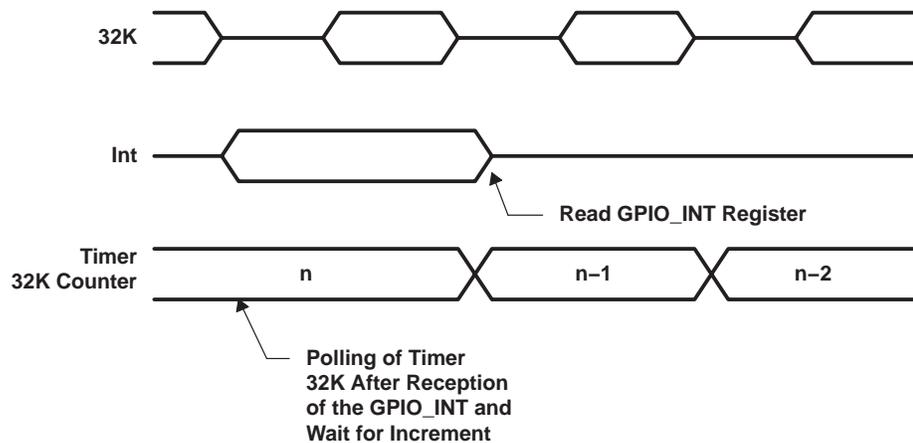
Figure 7. MPUIO Waveforms

There are different ways to detect a 0-to-1 transition on the 32-kHz system clock:

- Polling the timer 32k counter until there is an increment. See the waveforms in Figure 7, which describe the procedure.

- Loop-back the CLK32K_OUT output on one available MPUIO, GPIO, or KB.R input, and polling the corresponding register.
