TMS320TC1100
Digital Signal Processor
Silicon Errata

Silicon Revision 2.0, 1.0

SPRZ210I
October 2003
Revised April 2009

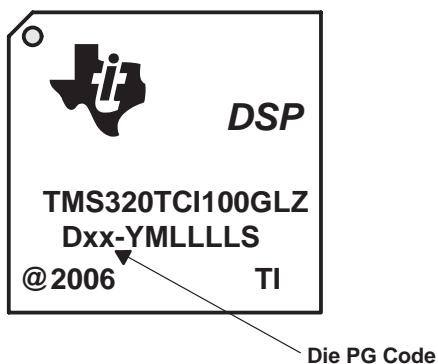
Figure 1. Example, Die PG Codes for TMS320TCI100 (GLZ)

The device revision can be determined by the Die PG code marked on the top of the package. The location of the Die PG code for the GLZ package is shown in Figure 1.

NOTE: Qualified devices are marked with the letters “TMS” at the beginning of the device name, while nonqualified devices are marked with the letters “TMX” or “TMP” at the beginning of the device name.
