AWR1243 DeviceSilicon Errata

Silicon Revisions 1.0, 2.0, and 3.0

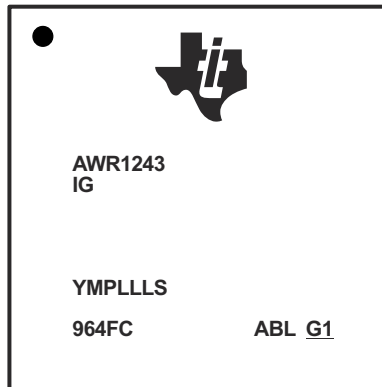
Figure 3-1. Example of Device Part Markings

Figure 3-1 shows an example of the AWR1243 Radar Device's package symbolization.

This identifying number contains the following information:
