## ABSTRACT

This document describes the known exceptions to the functional specifications (advisories).

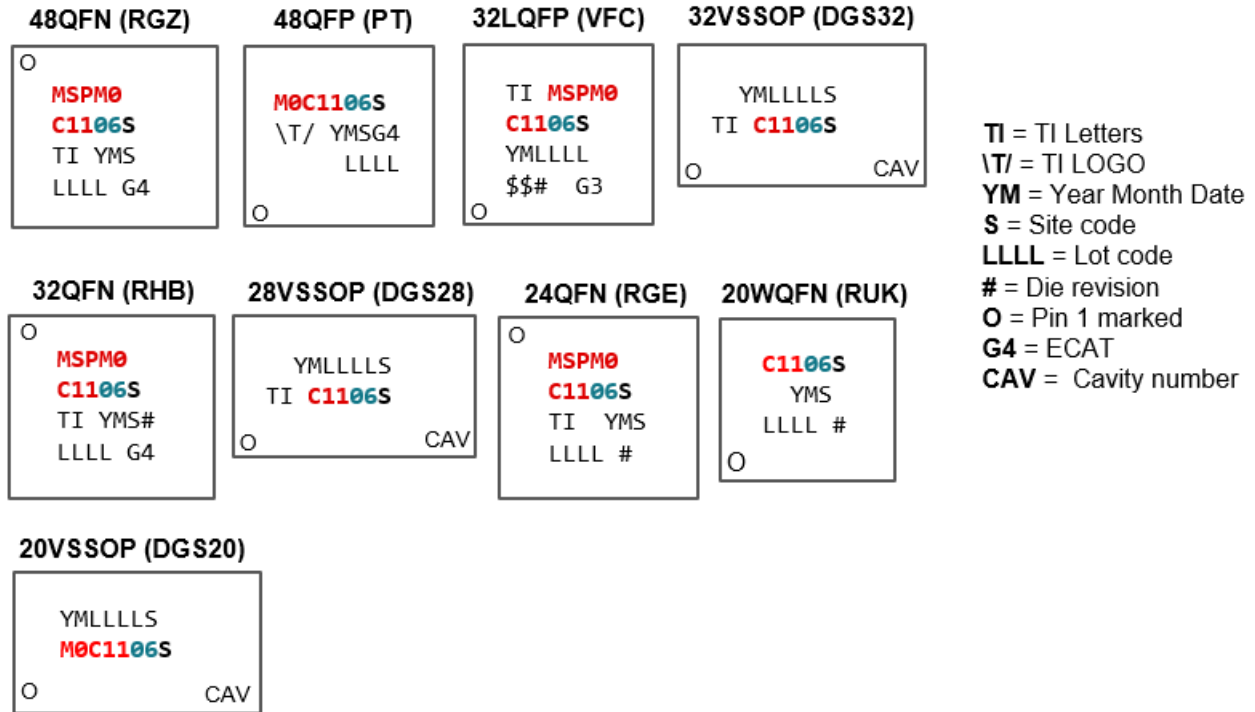
Figure 5-1. package Symbolization

The package diagrams below indicate the package symbolization scheme. And [Table 5-1](#) defines the device revision to version ID mapping.
